REPORT OF MARINE SURVEY

Pre-purchase Condition and Value

of the vessel bearing Hull Identification Number PEA56100077G

1977 36' Pearson 365 Ketch

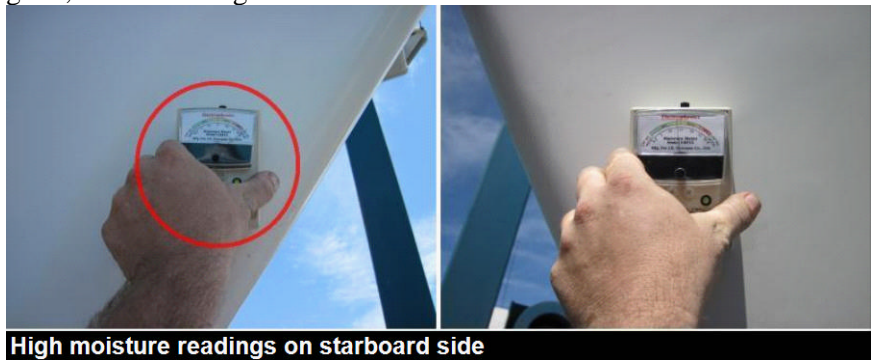
Solid, no cracks on external inspection. Moisture readings were relatively dry (less than 14%) on the port side stem. The starboard side stem had elevated moisture readings from 15% - +30% on the stem approximately three feet in height from the water line and approximately four feet aft from the stem. *Note: Moisture readings of 14% or less are considered dry for fiberglass.*

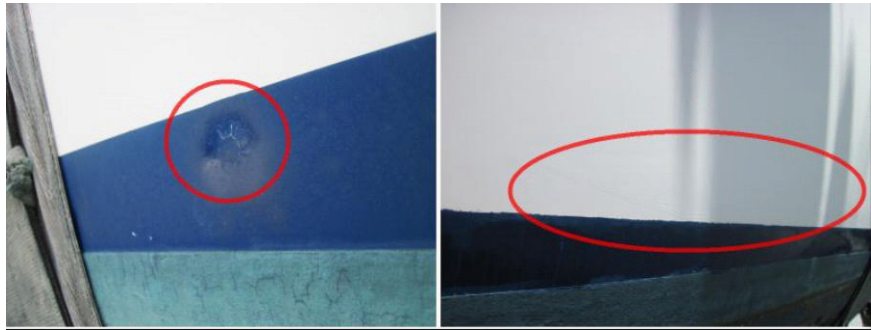
Areas of gel coat crazing on the topsides

Hull cosmetics were in good condition with only minor nicks and scratches sighted. Some crazing was sighted on the port and starboard hull areas near the water line (cosmetic only).

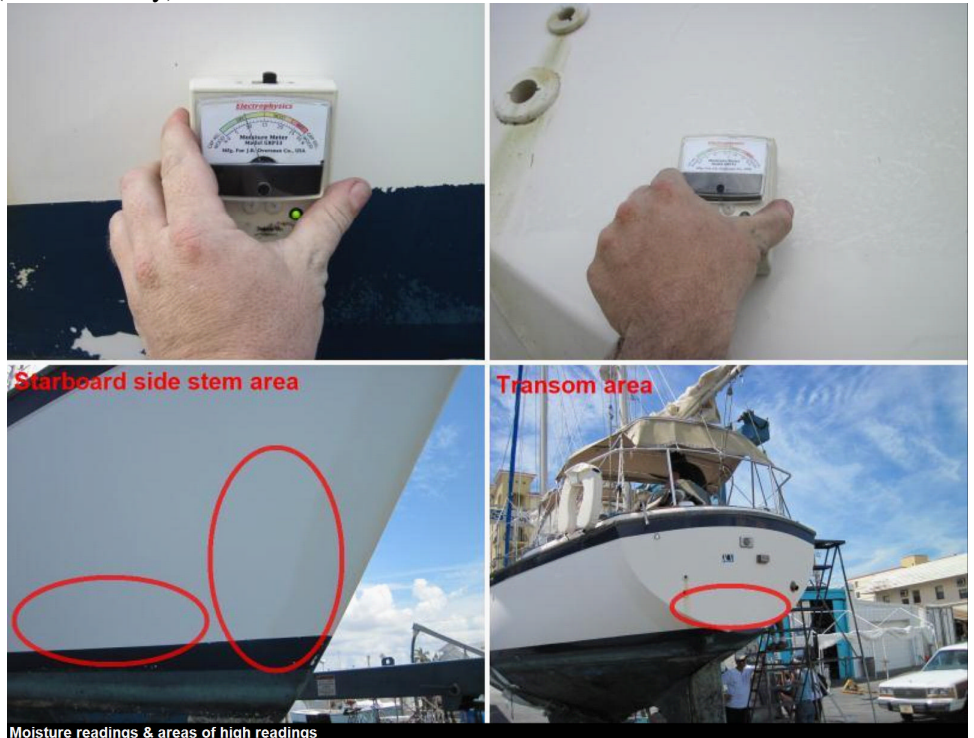
Moisture readings & areas of high readings

All moisture meter readings on side hull near the water line and surrounding thru hull fittings were relatively dry with normal comparative moisture meter readings (less than 14%). The exception was on the aft transom area near the water line and the starboard side near the stem (already mentioned above). Transom moisture readings near the water line were between 15% - 28%. The area was approximately two feet in height from the water line to the edges of the transom. No signs of delamination or blistering were sighted on the hull above the water line. No signs of structural stress cracks were sighted.

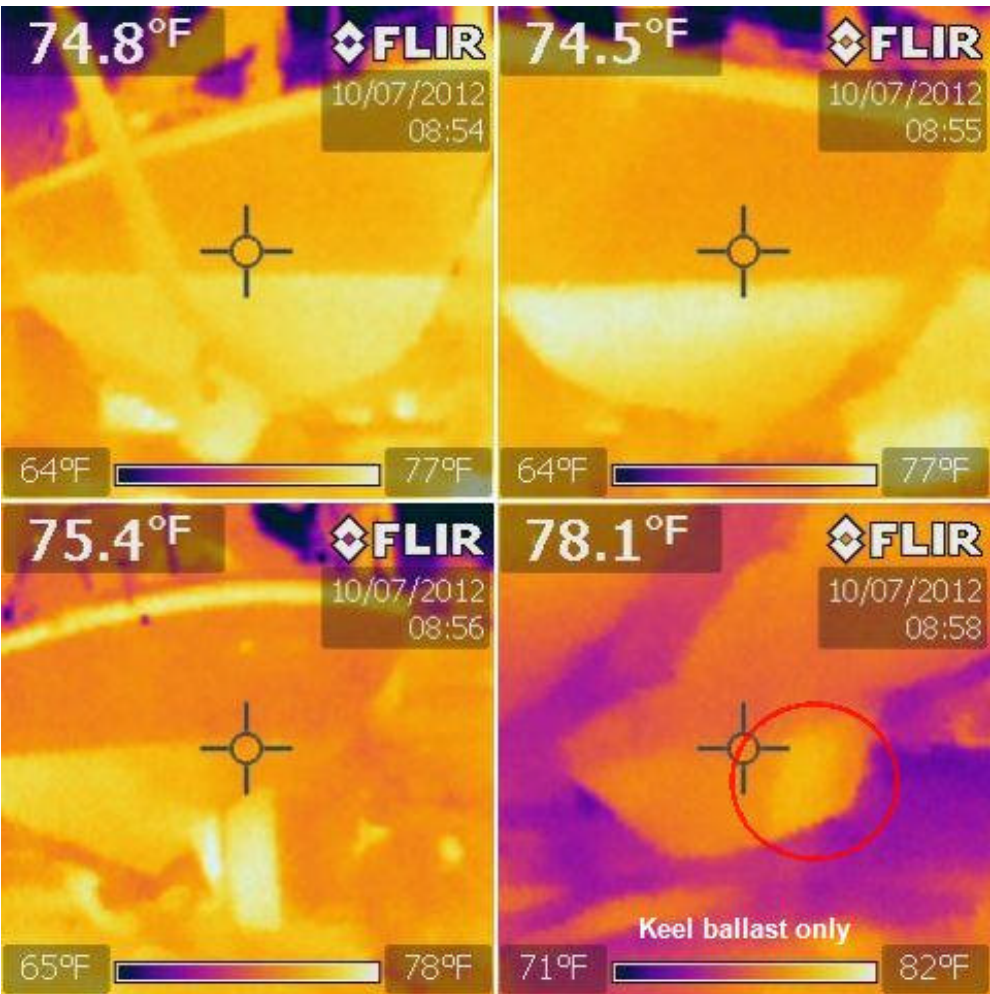
Normal thermal images of the fiberglass hull. No thermal anomalies indicating delamination was sighted with the thermal camera.

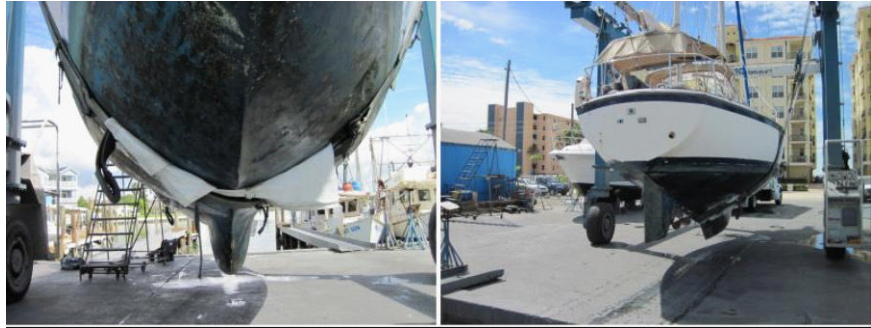
Hull bottom

Anti-fouling bottom paint in was sighted on the hull bottom. The anti-fouling paint was in average condition. There were some areas of minor sea growth and some faded areas of paint sighted.

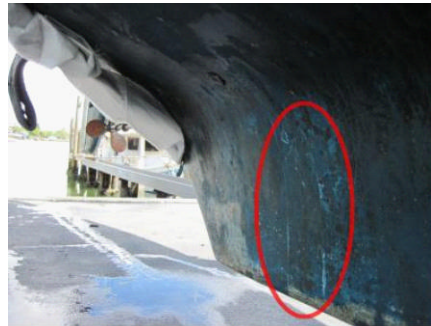
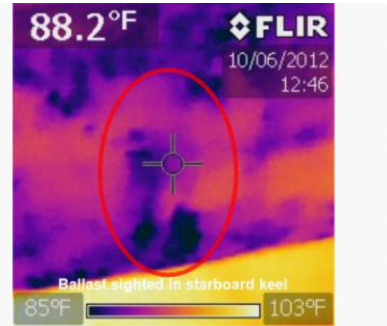
Starboard side keel with ballast in keel

Fin keel, molded in. The keel measured 13'6" in length and 2'6" in height (from the foot of the keel to the hull bottom). The keel was in average condition. The center of the keel was filled with ballast material from weight. No cracks or separations were sighted.

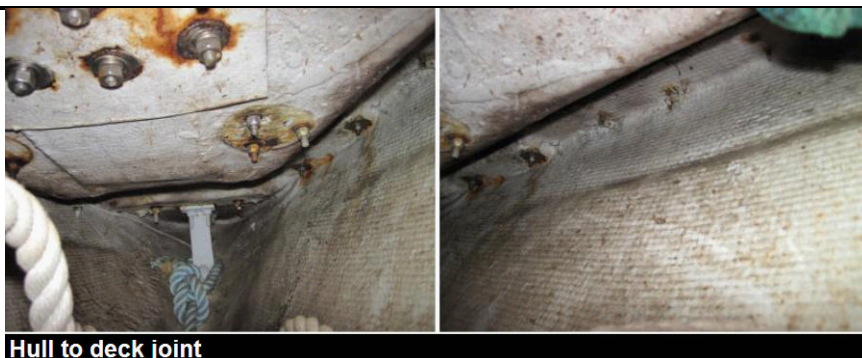
Hull to deck joint

Internal flanged type hull to deck joint. Elastomeric bonding compound was sighted in the hull to deck joint and reinforced with stainless steel fasteners. No leaks were sighted in any part of the hull to deck joint area.

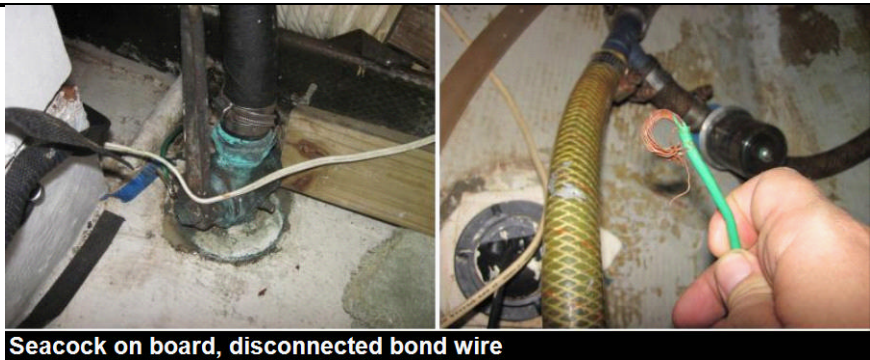
The raw water intake / discharge seacocks below the water line on this vessel were bronze ball valve type seacocks. All seacocks tested on board were properly secured to the hull. No leaks were sighted at any of the seacock locations. The port and starboard aft scupper drain seacocks were stuck in the open position. All other seacocks were functional but very difficult to open and close. All of the seacocks that could be sighted on this vessel were bonded however some bonding wires were loose or off of the seacocks.

| Findings: | Recommendations: |
|--|--|
| The water intake seacock for the head was sighted to not be bonded (had a disconnected bonding wire). Some bonding wires were held on improperly with stainless steel hose clamps around the seacocks. Port and starboard drain scupper seacocks were stuck in the open position and the valves would not close. Some other seacocks were difficult to open and close. | Have a qualified marine technician properly attach bonding wires to seacocks using proper spade type wire or direct fastener type connections to the seacocks. Have a qualified marine technician further inspect the seacocks that were stuck in the open position. Repair, replace or renew as necessary. <i>NOTE: All seacocks aboard a vessel should be in the closed position when the vessel is unattended. Seacock valves can and will corrode if left unattended. It is a good practice to turn the seacock valves regularly to insure the valves are working properly. Tapered wooden plugs tied to sea valves are an inexpensive safety item and highly recommended under current ABYC standards. Note: Dissimilar metals and metal alloys have different electrode potentials when two or more of these metals exist in the same electrolyte (such as seawater). When this happens a galvanic couple can be created and depending upon the nobility of the metal, one metal will become the anode and another metal will become the cathode and can form electrolysis between the two electrodes (the anode and the cathode). Once the galvanic couple is formed between the two metals, the anode metal will dissolve into the electrolyte. This electrochemical reaction is called galvanic corrosion and can occur on a vessel below the waterline between two metals that are different in nobility or charged at different levels. Bonding underwater metals together causes the metals to remain at the same potential and helps prevent or slows the galvanic corrosion process.</i> |

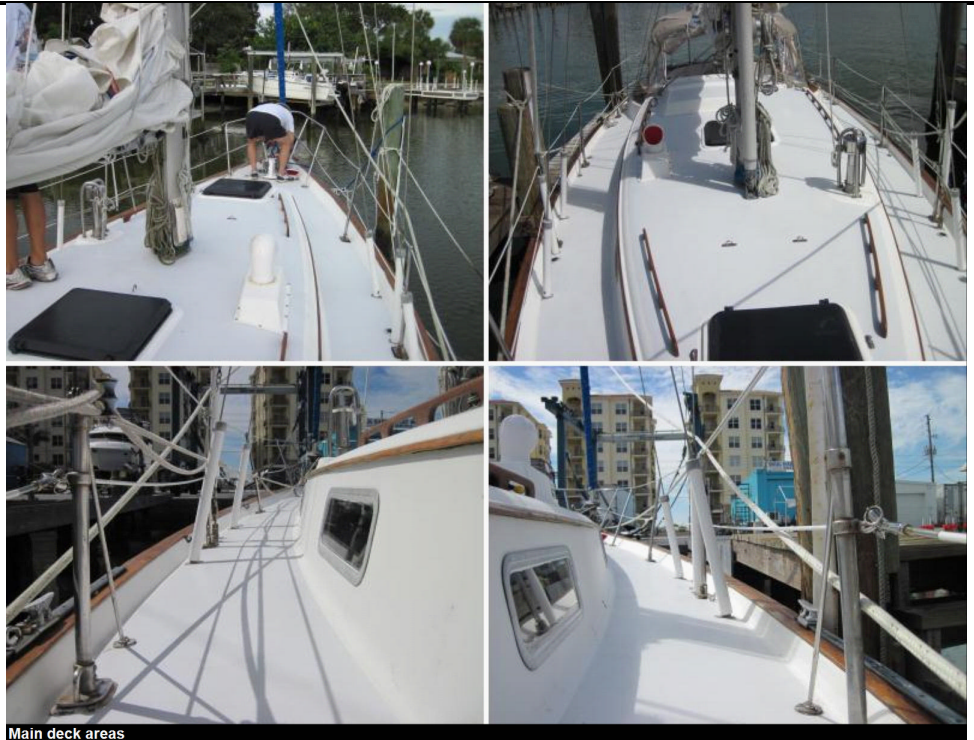
Molded, cored fiberglass deck construction. The core of this vessel was end grain balsa wood sandwiched between two layers of 1/8 inch fiberglass layers. The deck surface was white gel coat with a molded in non skid fiberglass surface. Some balsa wood was sighted to be deteriorated as seen through the deck pipe of the vessel near the anchor locker. Some areas of the cabin top and deck were found to have some deteriorated coring when tested with the phenolic hammer (approximately 15% of the deck and cabin top area).

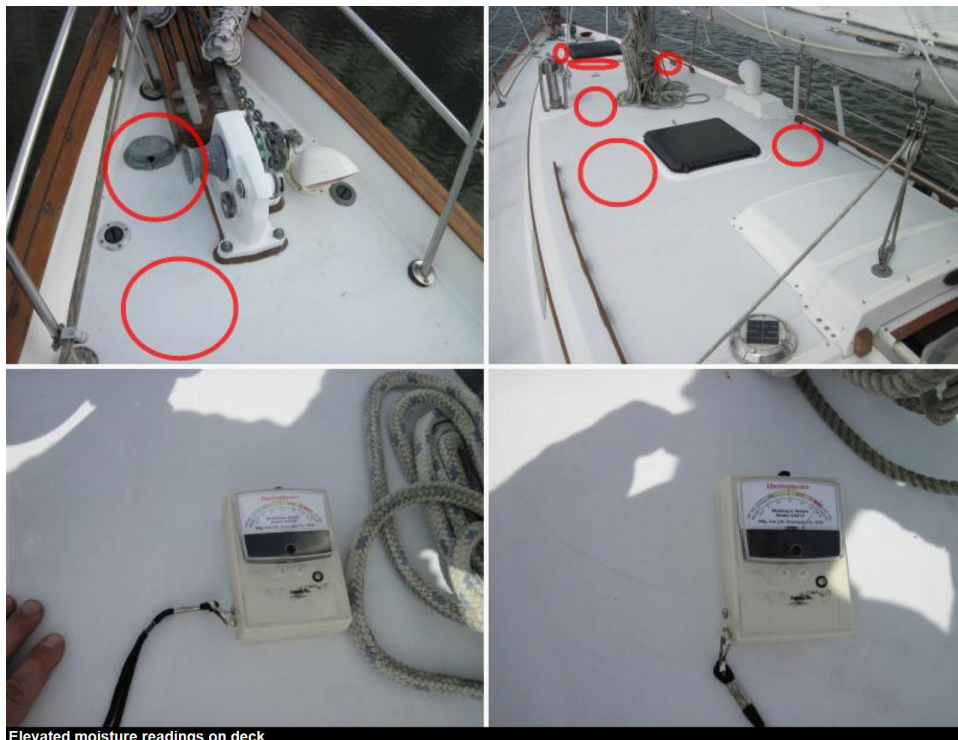
Elevated moisture readings on deck

Moisture meter readings were relatively dry (less than 14%) in most areas of the deck. Some elevated moisture areas were sighted around the cabin top, bow areas of the main deck, and the teak wood around the coaming of the cockpit (between 15% - +30%). No delamination or soft spots were discovered.

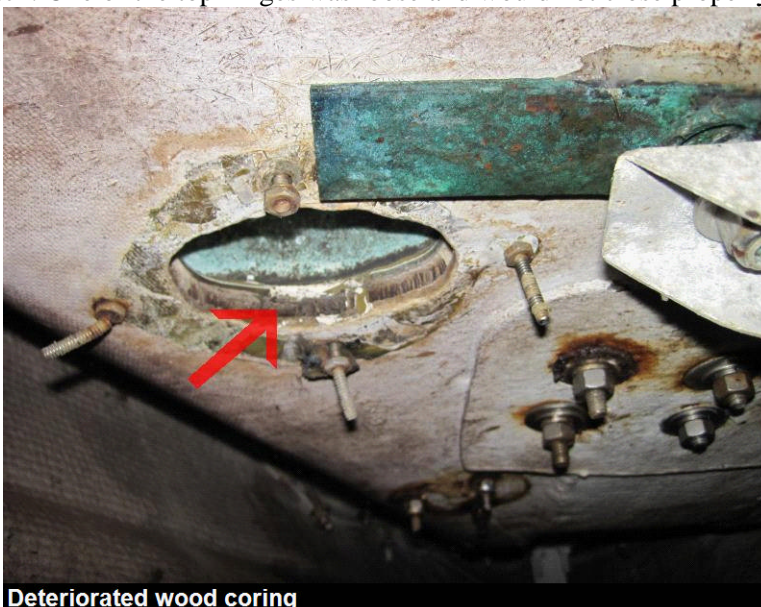
Deteriorated wood coring

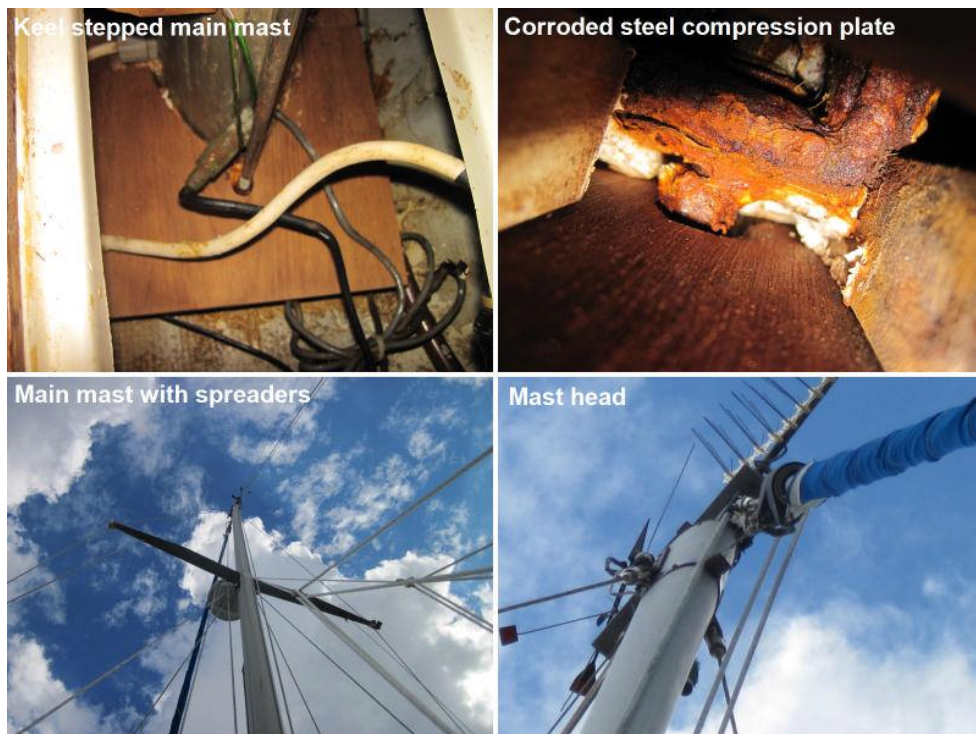
The main mast was keel stepped in the main salon. The mast was constructed of aluminum. The main mast sat on a steel compression plate and was fastened in to the keel with large fasteners on the compression plate. The mast had a single set of spreaders three quarters of the way up the mast and was reinforced with 5/16 inch and 3/8 inch diameter 1 x 19 stainless steel wire rigging. The mast appeared to be secure and in good condition. The compression plate appeared corroded when inspected.

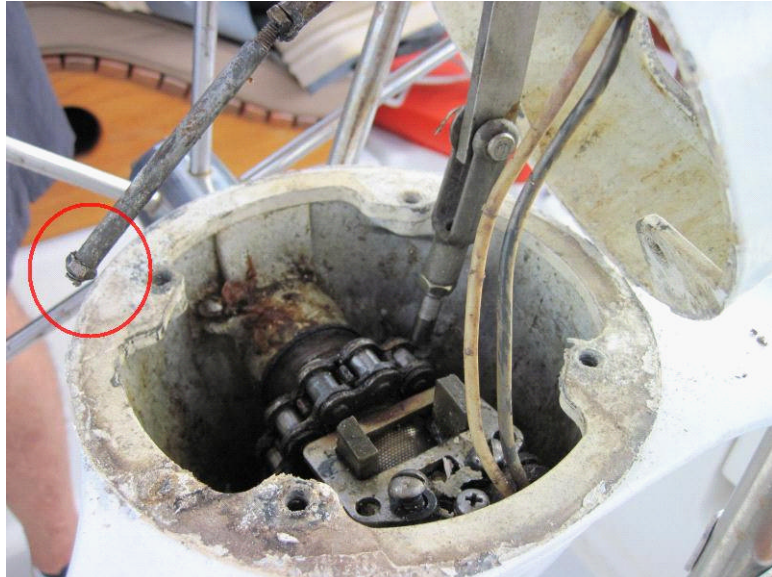
Broken throttle cable during sea trial

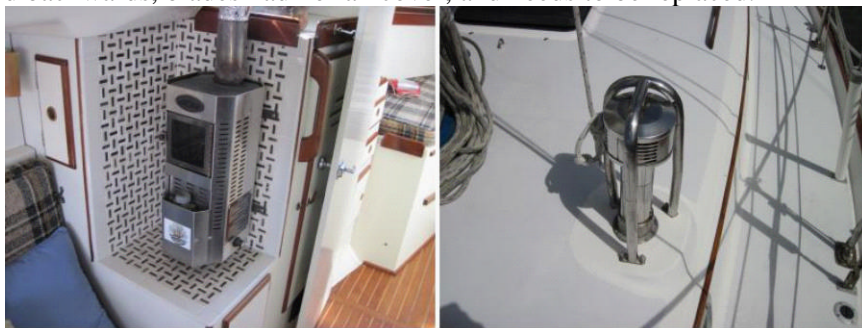
Cabin heater and charlie noble

One "Dickinson" brand "Newport" series oil heater was sighted on the port side of the main salon. The stove was surrounded by porcelain tile to protect the underlying wood and FRP surfaces. The heater vented to the above deck via a stainless steel charlie noble. The heater was not tested as part of this survey. The

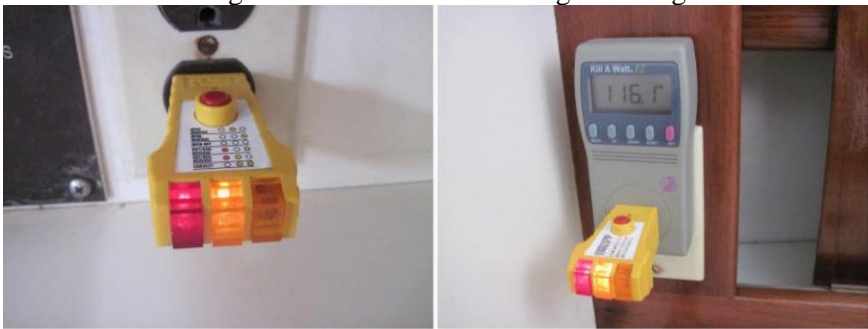
Hot / neutral reverse polarity

All of the 110 volt outlets on board had a hot / neutral reverse polarity when tested.

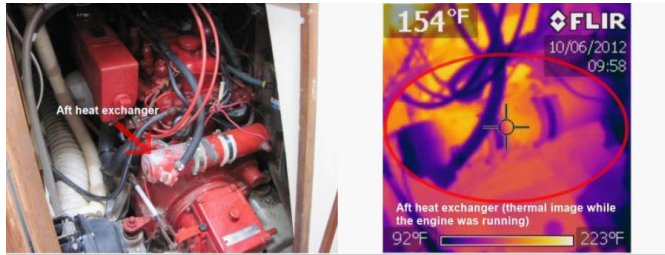
Uneven temperature anomalies in exchanger

Have a qualified marine technician properly adjust or replace the engine belt. Have a qualified marine technician further inspect the aft heat exchanger. Repair, replace or renew as necessary.

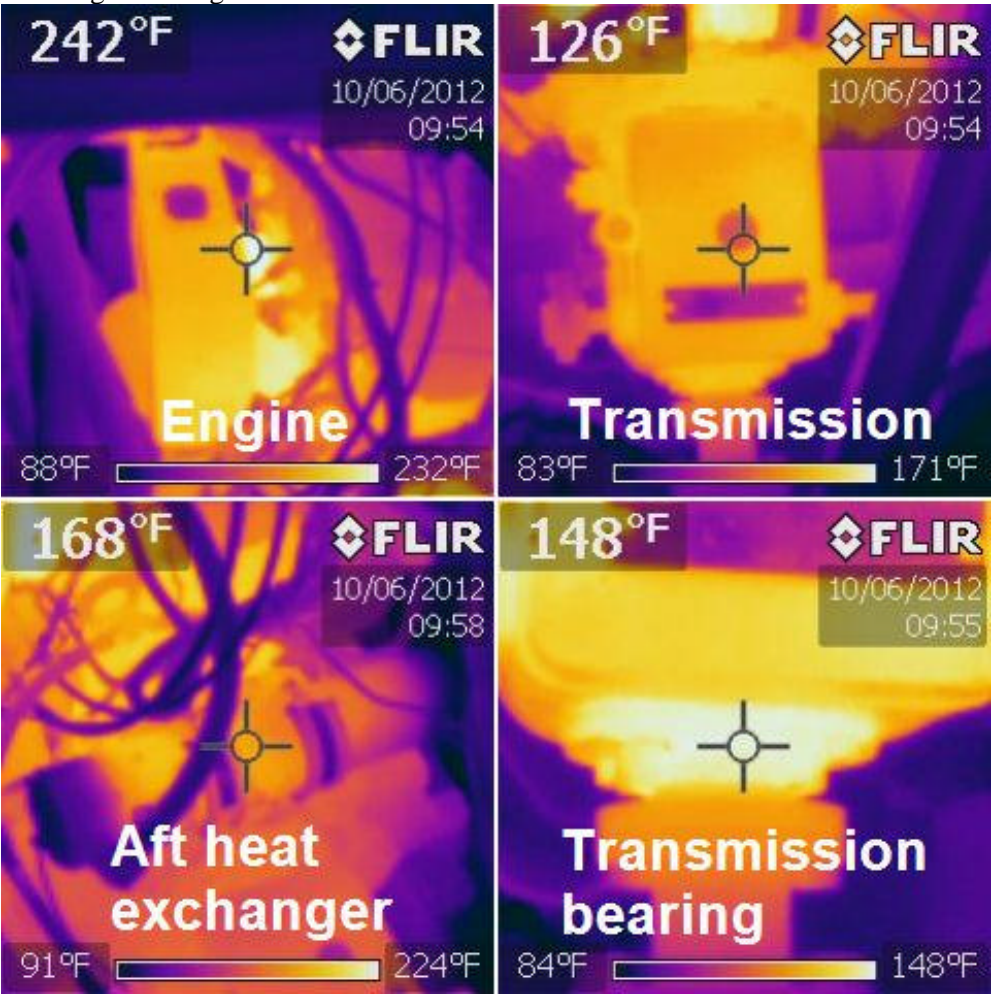
The engine block was running a little hotter than normal.
