REPORT OF MARINE SURVEY

Steel Hull Survey / Ultrasonic Testing of the Vessel

"New Smyrna Inlet"

1973 Diamond Manufacturing 42' Tug and Towing Vessel

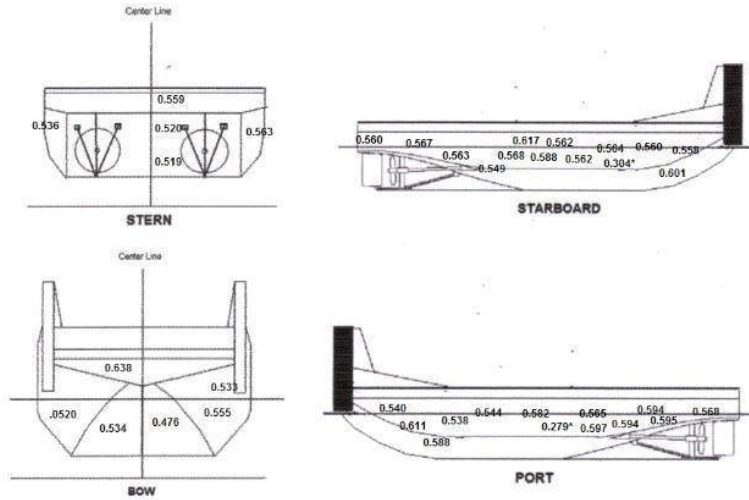
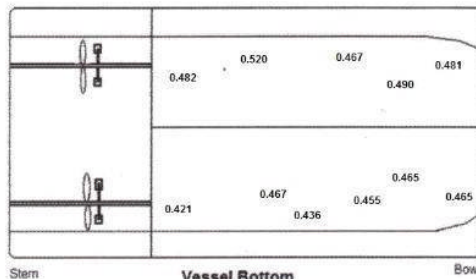
Project / Survey	Type	Report File Number	Sheet Of
M/V New Smyrna Inlet	HULL PLATE SURVEY	10-000003	1 / 1

* READINGS OF 0.304 FROM STARBOARD AND 0.279 FROM PORT WERE TAKEN FROM STRAKE PLATES THAT WERE WELDED OVER THE SOLID HULL. ULTRASONIC READINGS IN BETWEEN STRAKE PLATES WERE AT LEAST 0.500 AROUND THOSE AREAS.

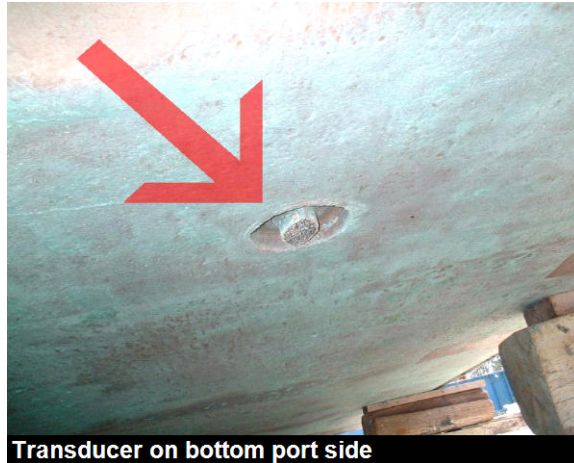
Transducer on bottom port side

One transducer was sighted on the bottom exterior hull that was filled with sand. **RECOMMENDATION:** Clean out transducer, test, repair, or replace as needed by a qualified technician.

One transducer was sighted on the bottom exterior hull that was filled with sand. RECOMMENDATION: Clean out transducer, test, repair, or replace as needed by a qualified technician.

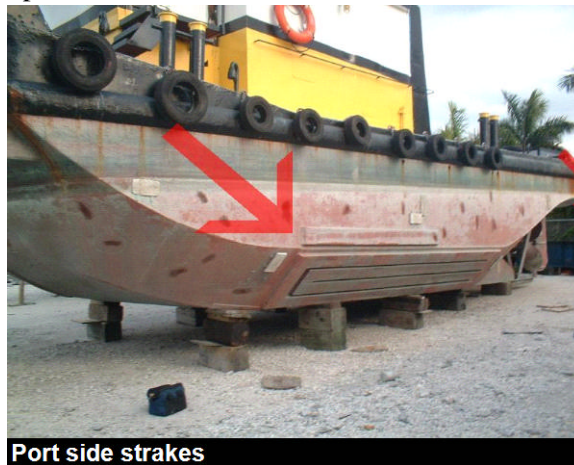
Port side strakes

The bottom was in good condition. Smaller ultrasonic soundings of 0.279 - 0.304 were taken of the exterior strakes that were welded on the port and starboard sides of the hulls. The strakes were welded on over the solid hull which measured at least 0.500 in between the strake areas.

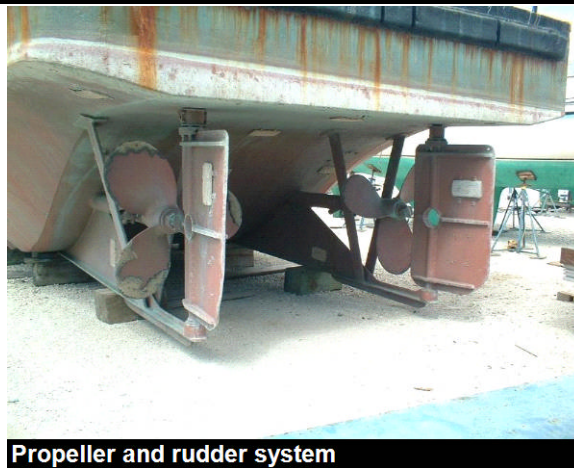
Propeller and rudder system

Strut(s): Two propellers have three blades and are made of a steel and bronze. Two struts reinforcing each propeller shaft.
Condition summary: The propeller, shaft, strut, and rudder system appears to be in good condition. Only minor corrosion was sighted.
Damage sighted: None.

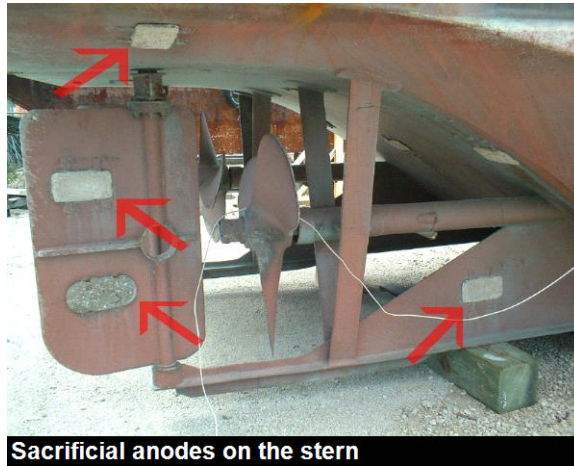
Sacrificial anodes on the stern

All anodes on the vessel appear to be approximately 50% worn. It is recommended they be replaced before the vessel is to be put back into the water for a long period of time.

Monitor all anodes frequently and replace when they are no more than 50% wasted. Anodes are normal replacement items designed to protect the running gear from electrolysis. Keep spares aboard vessel.

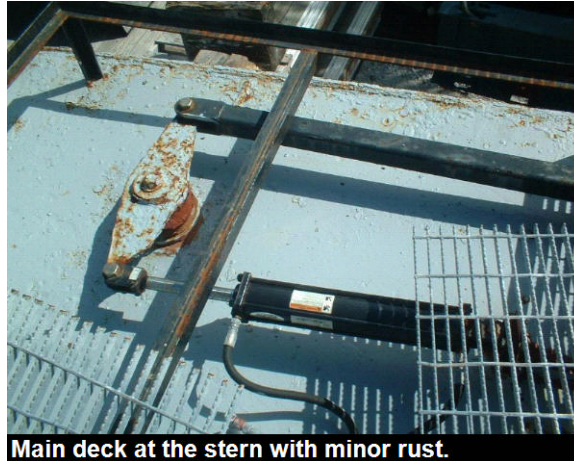
Main deck at the stern with minor rust.

Damage sighted: Decks are in good condition. Only minor corrosion was sighted.
 No significant damage was sighted.
