REPORT OF MARINE SURVEY

Pre-purchase Condition and Value

of the vessel bearing Hull Identification Number PEA56100077G

1977 36' Pearson 365 Ketch

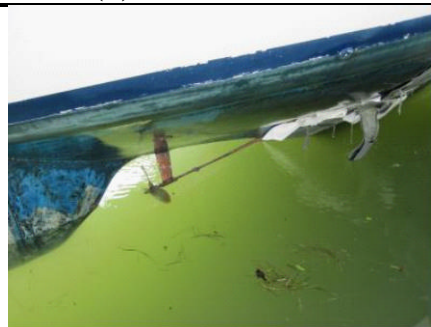
Shaft and vee drive assembly

The propeller on this vessel was a three bladed bronze propeller. The propeller measured 17 inches in diameter and was well balanced and secure to the shaft when tested. The pitch was labeled to be 12 inches, LH (left handed). The propeller nuts were reversed and incorrectly installed.

| Findings: | Recommendations: |
|--|--|
| The propeller nuts were incorrectly installed. | Have a qualified marine technician re-install the propeller nuts. <i>Note: Per ABYC P-6 recommendations, the narrow nut (also called a jam nut) should be installed against the prop and the thicker nut should be installed behind the narrow jam nut, then properly cotter pinned.</i> |

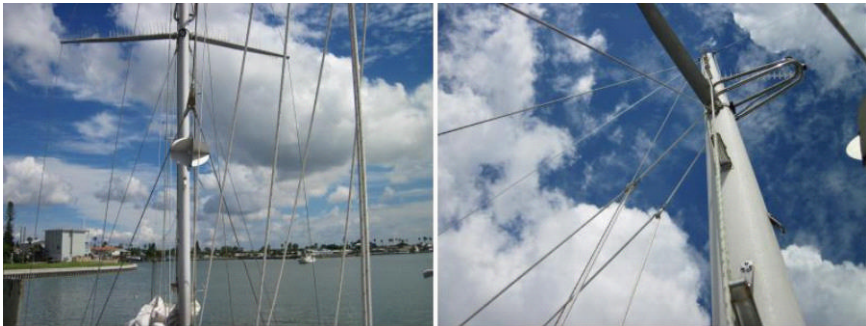
One deck stepped aluminum mizzen mast was sighted in the fore section of the cockpit. The mizzen mast had a single set of spreaders. The mizzen mast had a single set of spreaders three quarters of the way up the mast and was reinforced with 5/16 inch diameter 1 x 19 stainless steel wire rigging. The mizzen mast appeared to be secure and in good condition. The mizzen mast had stainless steel mast steps going up the length of the mast. All of the steps appeared secure. Mizzen mast had the day shape for "vessel at anchor" attached to its fore end. Metal bird spikes were sighted on both spreaders on the masts to prevent birds from perching on the tops of the spreaders.

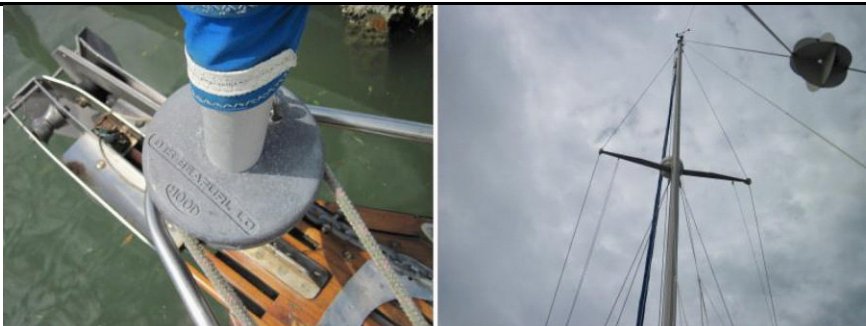
Jib roller furling

The forward jib roller furling gear was a "Hood" brand "810 Seafurl Lo" series roller furling. The roller furling was properly attached to the mast head and deck fittings and was functional when tested. Furling and jib lines were properly supported and clear of other gear and lines on board. Good condition.

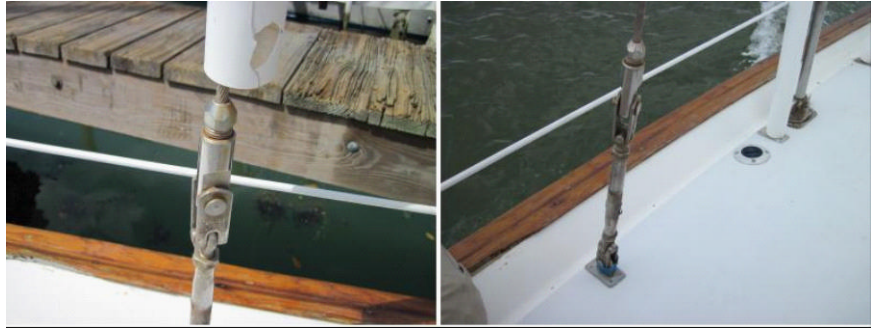
Turnbuckles on the deck

Stainless steel turnbuckles, tang ends, cleavis pins, and cotter pins appeared to be in good condition with no signs of corrosion. The wire rope terminated into Norseman like termination ends that connected to the turnbuckle rods. All of the turnbuckles connected to the chain plates appeared to be in good condition with no signs of significant corrosion, cracks or loose areas. Port and starboard turnbuckles were protected with PVC pipes over the wire rope and turnbuckles (three on each side).

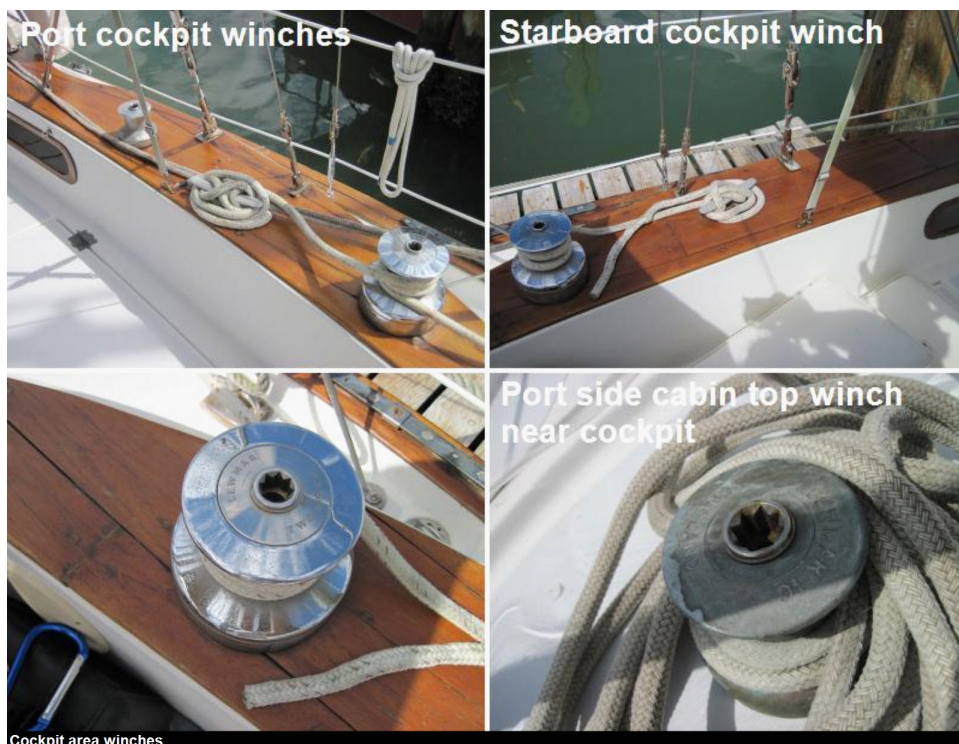
The winches in the cockpit were "Lewmar" brand, two speed, stainless steel, self tailing winches. The following were the winches in the cockpit area: Port side coaming were one number 42 winch and one number 16 winch. Starboard side coaming was one number 42 winch. On the cabin top were one port side number 16 winch. All winches turned both ways properly when tested and appeared well secured to the vessel.

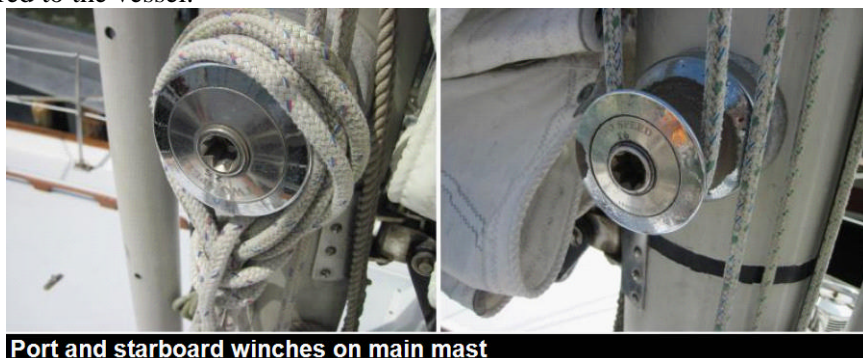
Two (one port and one starboard) "Lewmar" brand stainless steel, two speed winches were sighted on the mast just above the gooseneck. The winches worked properly when tested and appeared well secured. The port side winch was a number 25 winch. The starboard side winch was a number 16 winch.

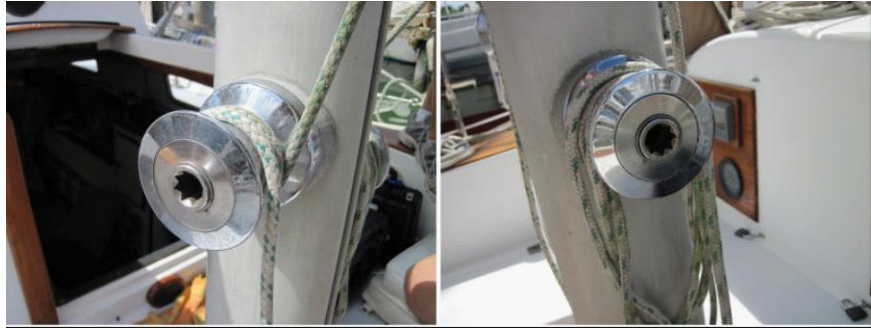
Port and starboard winches on mizzen mast

Two (one port and one starboard) "Lewmar" brand stainless steel, single speed winches were sighted on the mast below the gooseneck. The winches worked properly when tested and appeared well secured. Both winches were number 8 winches.

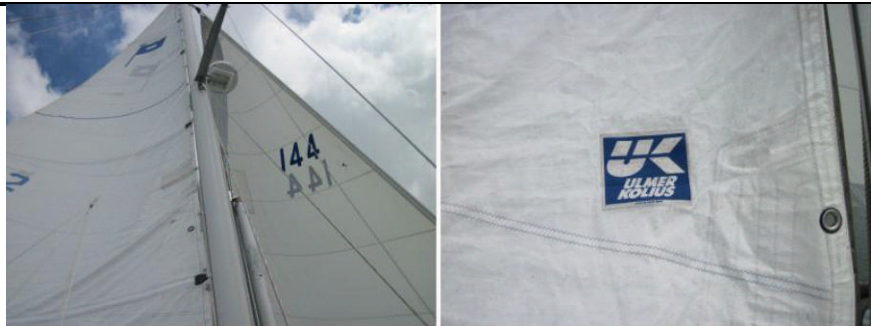
Main sail and jib under sail.

The main sail was a fully battened sail. The sail had no reefing points on the main sail. The sail was an "Ulmer Kolius" brand sail and appeared to be in average condition during the sea trial. The sail appeared to be made of Dacron. No holes or broken stitching upon inspection. One of the lowest sail cars was off the sail track during the sea trial.

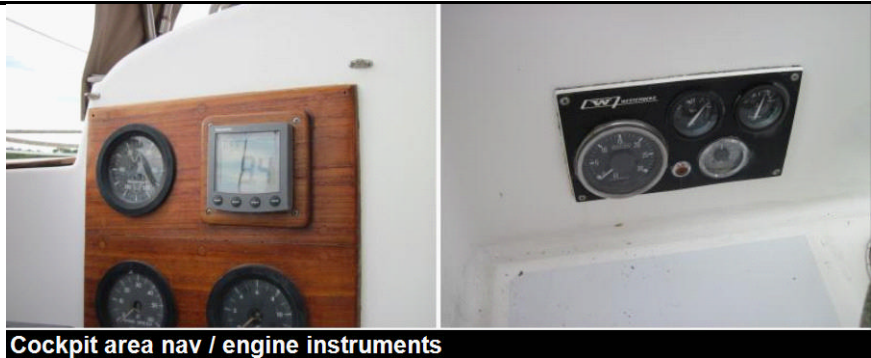
Cockpit area nav / engine instruments

Electronics mounted on the port and starboard cockpit bulkheads and on the starboard side bulkhead near the deck in the cockpit area. All of the electronics except for the "Raymarine" brand digital depth sounder were not functional when tested.

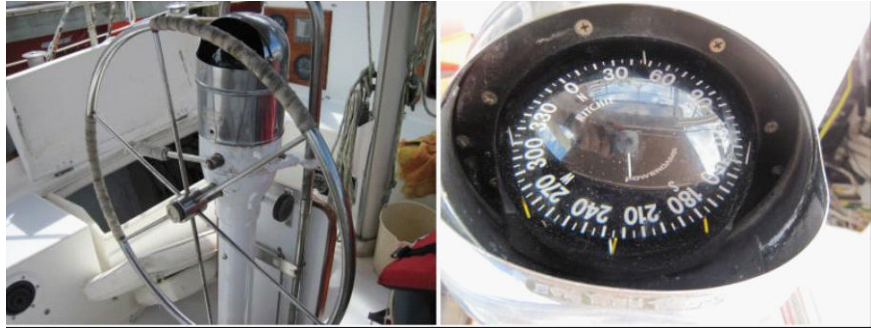
Helm pedestal with working compass

The magnetic compass at the helm station was a "Ritchie" brand "Powerdamp" series compass. The compass appeared to be working properly with very little deviation.

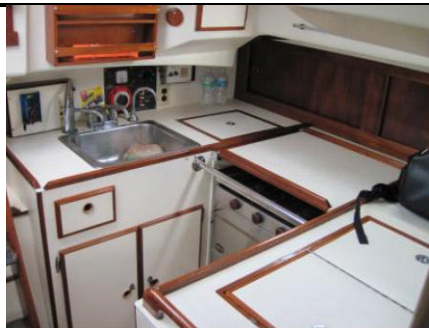
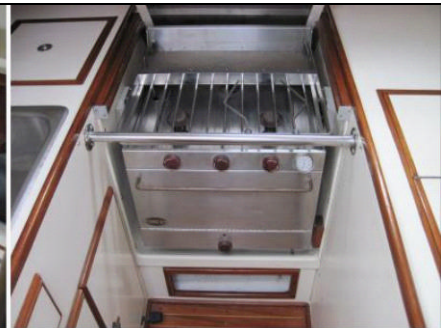
Galley and stove

The stove was "Force 10" brand stainless steel alcohol stove. The stove was gimballed and had three burners and an oven. The pressurized alcohol tank was sighted on the starboard aft side of the main salon and was manually pressurized. The tank was able to hold pressure when tested, however the stove did not feed alcohol to the burners when tested.

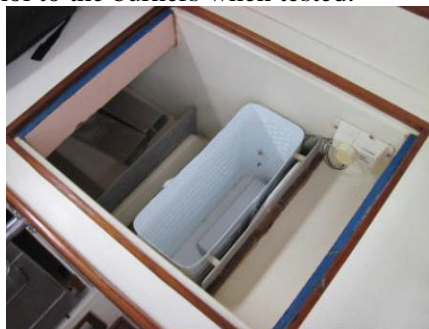
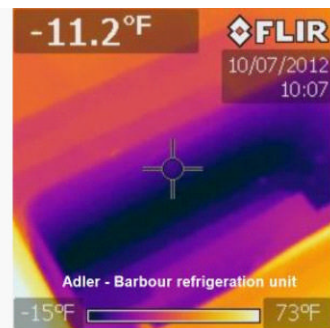
Refrigeration / freezer & thermal image

The refrigeration unit was a 12 volt "Adler - Barbour" brand refrigeration / freezer unit that was recessed into the forward counter of the galley. The unit was functional when tested.

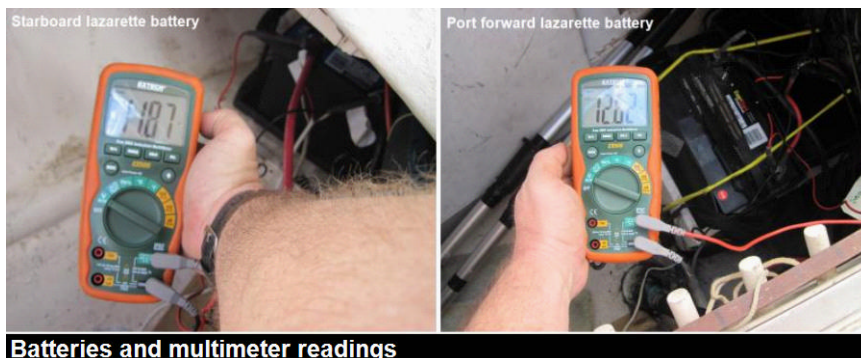
Batteries and multimeter readings

The primary batteries on board this vessel were one 12 volt "Duralast" brand, lead / acid battery (model number 24-MD-DL, sighted in the starboard side aft lazarette) and one 12 volt "EverStart" brand, lead / acid battery (model number 27DC-6, sighted in the port side forward lazarette). The batteries were both deep cycle marine batteries and were rated at 550 CCA (cold cranking amps) and 600 CCA respectively. The batteries were charged between 11.87 - 12.62 volts when tested with a multimeter. The batteries were wired in a parallel circuit and were designated for engine start (Duralast battery) and house battery use (EverStart battery). The batteries were secure to the vessel. The batteries were wired with proper 1 AWG battery cable.

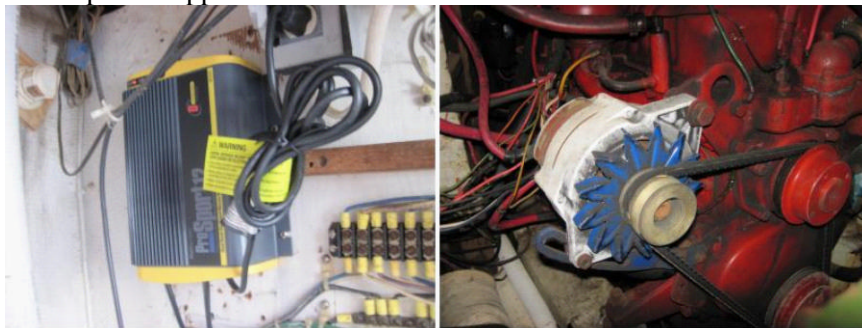
Battery charger and Balmar alternator

The vessel's batteries could be charged via the onboard 120 volt "Pro Mariner" brand marine battery charger or via the vessel's engine "Balmar" marine alternator. The 120 volt battery powered up when tested. The vessel's alternator charged both batteries during the sea trial.

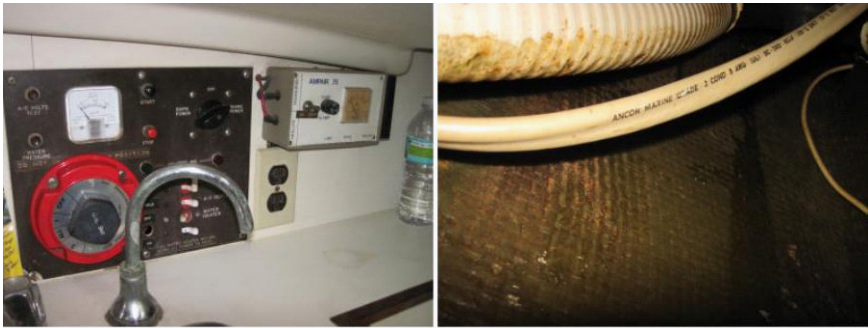
AC distribution power and AC boat cable

All of the 110 volt outlets on board had a hot / neutral reverse polarity when tested.

- AC power / shore dial switch located in main AC panel in the galley area. No generator was on board.

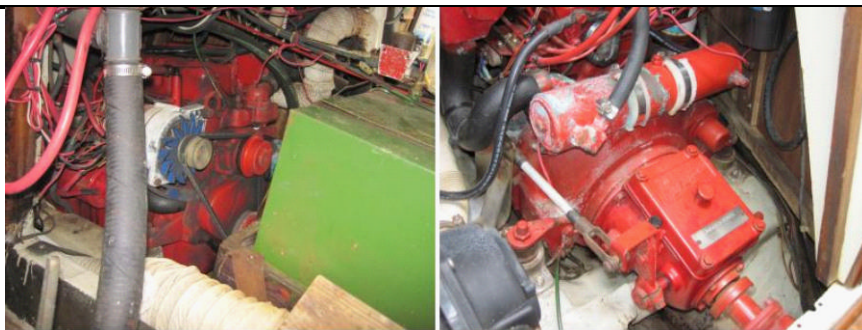
Fore and aft ends of the diesel engine

The engine that powered this vessel was a "Westerbeke" brand "40" model four cylinder, four cycle, 37 horsepower inboard diesel engine. The engine was naturally aspirated.

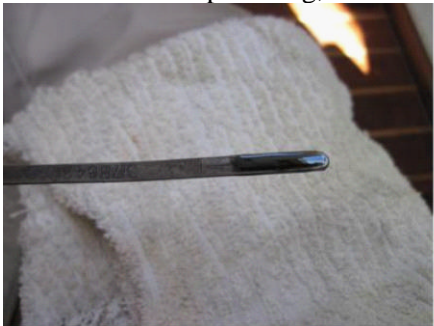
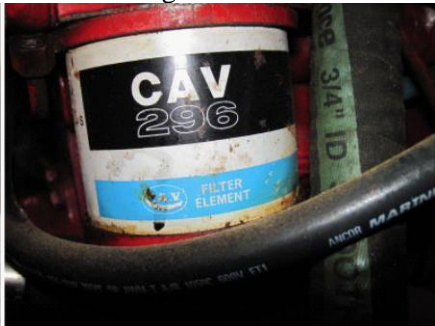
Oil level and fuel filter on engine

108U9485B710.
Not sighted on board.
Average condition, no cracks sighted.
The belt on the engine was loose with some excess belt deflection when tested.
Belt dust was sighted on the front of the engine (which faces aft in the lazarette because of the vee drive configuration).
Fresh water closed loop cooling, raw water heat exchanger cooled.

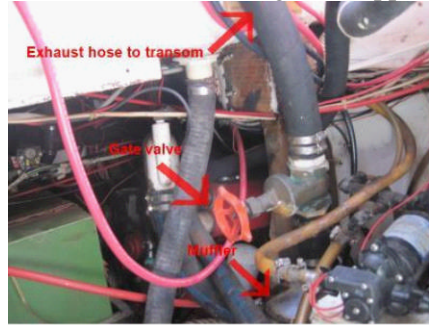
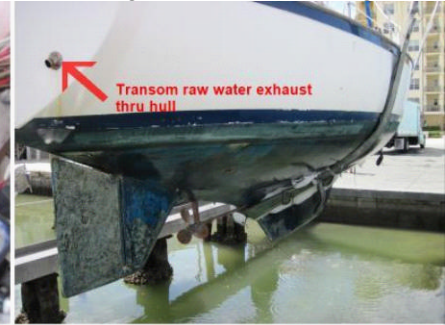
Wet exhaust system

Aluminum water lift type muffler. No leaks sighted. Sighted in the starboard side lazarette near the water heater.

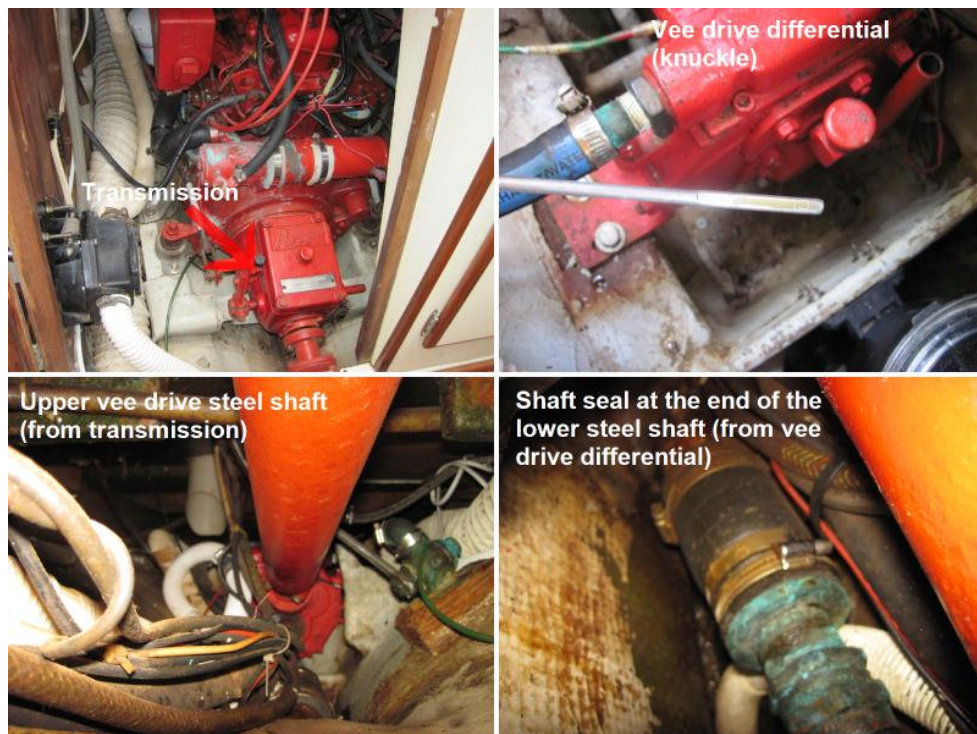
The aft transmission was a "Paragon" brand transmission. The transmission was controlled by a manual cable and was fully functional when tested during the sea trial. The unit was connected to a vee drive differential unit sighted forward of the transmission under the main salon sole. The vee drive had a hard impeller built into it that pressurized raw water to the engine and helped cool the vee drive hydraulic fluid. The vee drive had proper and clean fluid when checked. The vee drive unit was functional when tested.

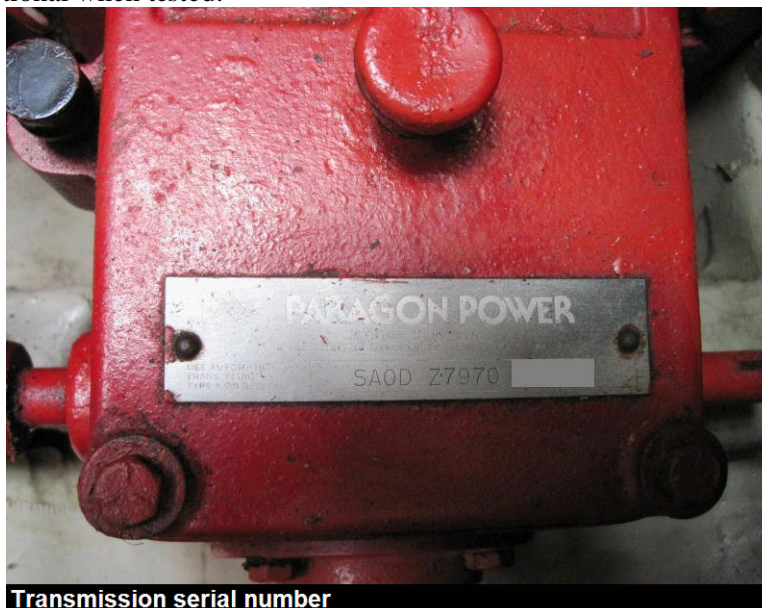
Transmission serial number

SAQDZ79706M380.

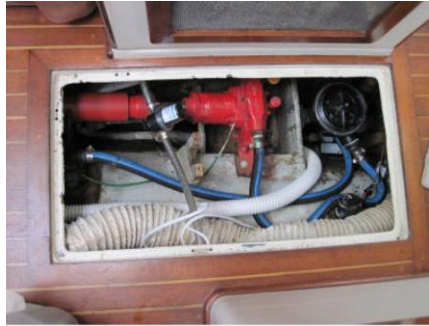
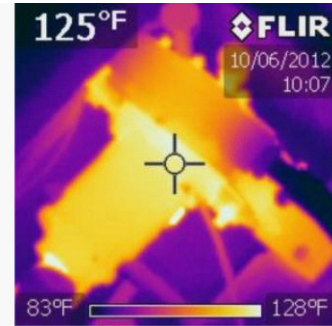
Vee drive system running

The vee drive system was tested with a thermal camera. The vee drive system was running normally with no unusual temperatures or gear noise sighted or heard.

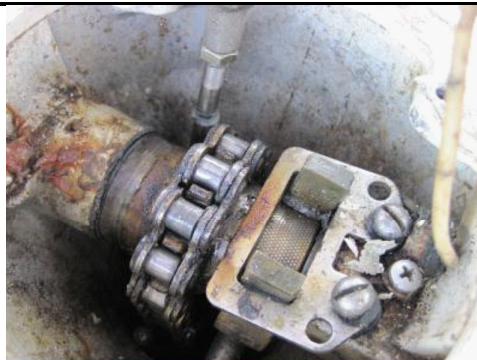
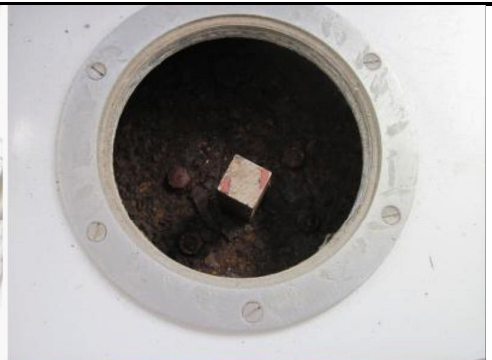
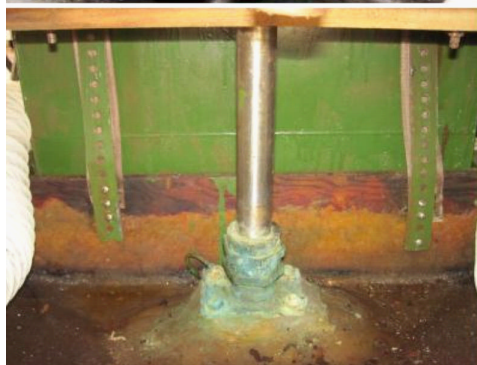
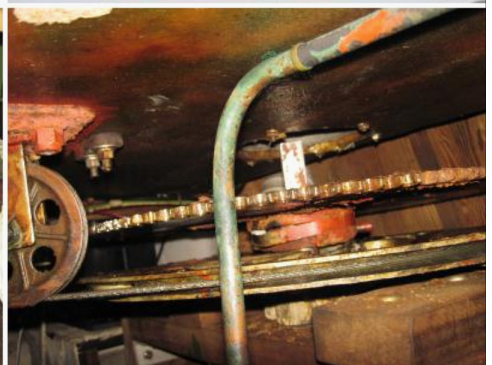
Steering system

The steering system on board this vessel was a manual cable / chain over pulley system. The steering system worked properly when tested and turned both ways equally. No leaks were sighted in the rudder post pass through location or around the packing glands during the sea trial. Cables, chains, and pulleys appeared secure and in average condition. The steel steering quadrant was in average condition with cables terminated and properly secure in the quadrant. Adequate tension was on the cables when tested. Some surface corrosion was sighted on the top of the steering quadrant.

The top of the steering quadrant was sighted to be corroded. The emergency tiller deck cover (made of aluminum) had holes going through the cover allowing water to get to the top of the steering quadrant.

Have a qualified marine technician further inspect the steering quadrant and cover to the emergency tiller. Replace, repair or renew as necessary.

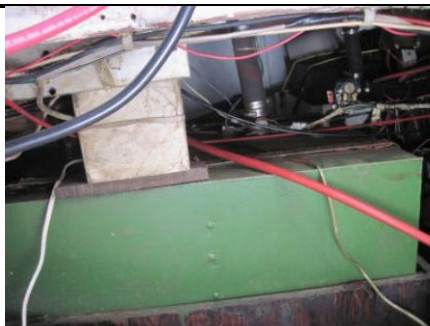
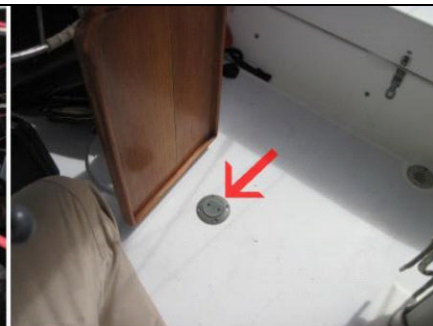
Fuel tank & fuel fill deck fitting

One fuel tank was sighted below the aft cockpit deck. The tank appeared to be in good condition with no leaks sighted. The tank was mounted on a flat surface and appeared well secured. No leaks were sighted on the tank.

One bronze fuel fitting was sighted on the center of the cockpit deck forward of the helm pedestal. The fill hose was a USCG type B2 fill hose and was properly double clamped and grounded. No leaks were sighted in the hose or around the clamps where they could be seen.

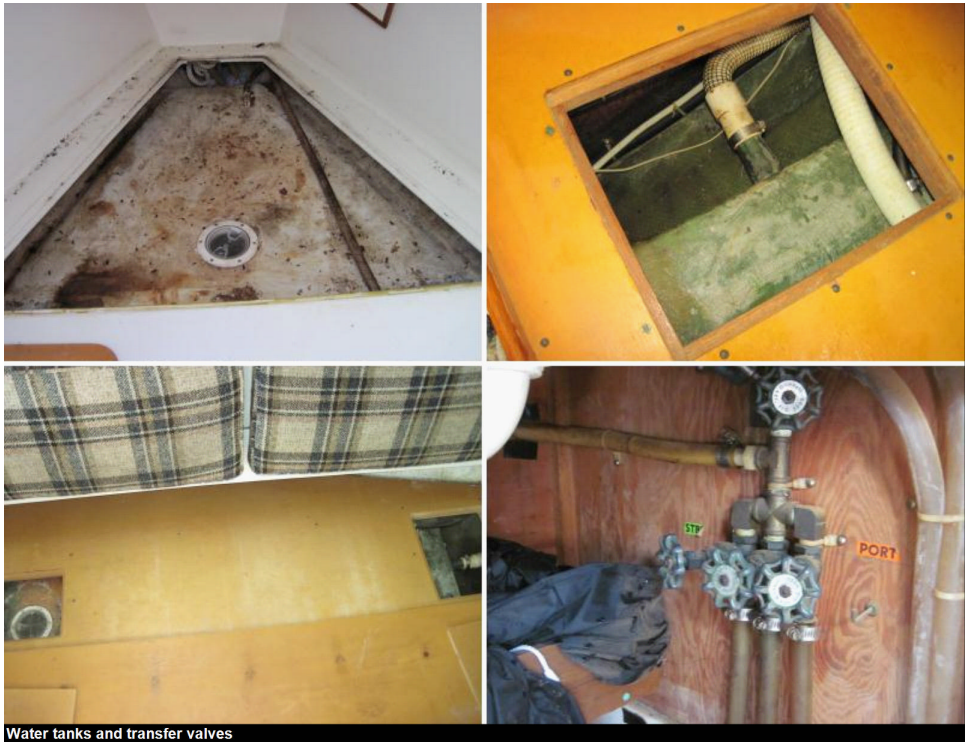
A total of three water tanks were sighted on board this vessel. One under the forward "V" berth bunk, and two tanks sighted in the main salon (one each under each bench seating). The tanks appeared to be made from FRP. Each tank was rated to hold 50 gallons each (150 gallons total). All of the tanks appeared well secured, vented, and on a flat surface. The water fill for the tanks were bronze type deck fills sighted on the port and starboard decks outboard of the cabin top and at the port bow near the windlass. The deck fills and plastic hoses were properly secured and appeared to be in good condition. No leaks were sighted in the potable water system or tank. Transfer valves for the potable water system were gate valves sighted under the galley sink. All of the transfer valves worked properly when tested.

| Findings: | Recommendations: |
|---|---|
| The forward "V" berth tank had mouse urine and waste on the surface of the tank. Signs of a mouse's nest could be sighted in a small space just forward of the "V" berth water tank. The interior of the "V" berth tank was dirty and should be cleaned. The forward bow pump and deck fitting for fresh water wash down were not functional. | Have a qualified marine technician properly clean up the mouse waste and interior of the forward water tank. If a mouse is on board it should be removed. Mice and rats will eat through wiring and lines on board. If desired, replace the old bow pump and wash down fitting on deck. |

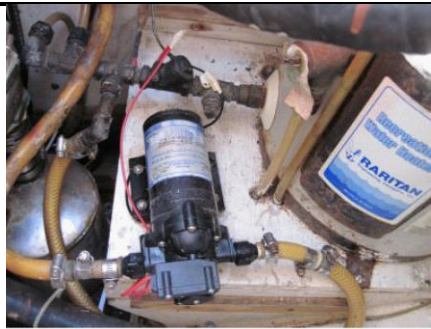
Water pump and hot water heater

One 120 volt "Raritan" brand "R6S" model stainless steel water heater was sighted in the starboard side lazarette (serial number HF 9607206). The unit was heat exchanger heated from the engine or AC power heated. The unit had a rated capacity of six gallons and appeared to be well secured and in good condition.

Ignition protected: Yes.
Other notes: Some minor corrosion was sighted on the surface of the tank.
Condition summary: Average condition.

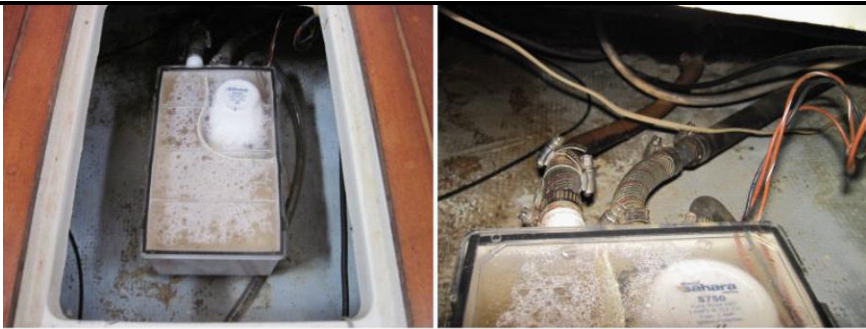
Grey water tank and hose fittings

One grey water tank was sighted under the main salon sole near the head. The grey water tank was made of plastic and was covered. Inside the grey water tank was a 12 volt "Rule" brand "Sahara" series 750 GPH pump with a built in float switch. The pump did not power up when tested.

| Findings: | Recommendations: |
|---|--|
| The small grey water tank under the forward cabin sole had a non-functional pump and was overflowing with water when inspected. | Have a qualified marine technician further inspect this grey water tank. Repair or replace as necessary. |

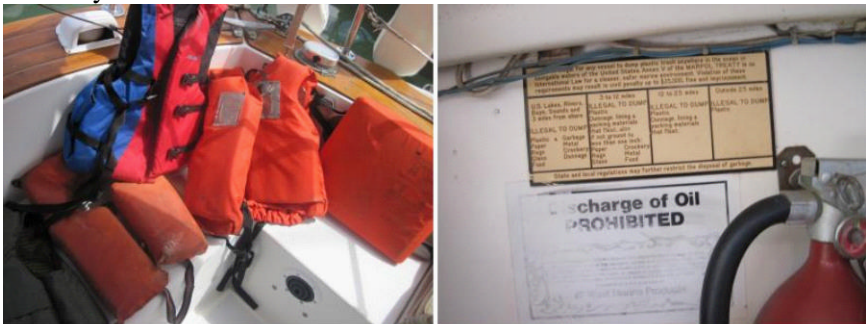
Life jackets and USCG required placards

The following USCG approved life jackets were sighted on board: One type I life jacket, one type II life jacket, two type III life jackets. All of the life jackets were in serviceable condition.

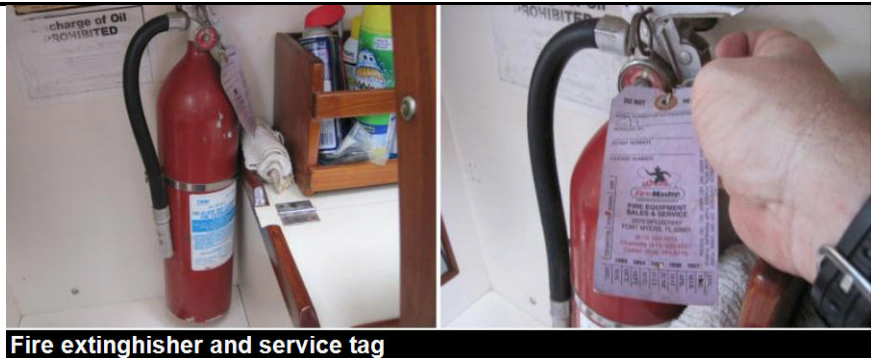
Fire extinguisher and service tag

Two "TRW" brand USCG approved fire extinguishers were sighted on this vessel. The fire extinguishers were properly charged and rated for A, B, and C rated fires (one sighted near the galley and one sighted at the navigation station). The fire extinguishers showed they were charged but were tagged to have been last serviced in 1995.

| Findings: | Recommendations: |
|--|--|
| No current annual inspection tags were sighted on the portable fire extinguishers. | ABYC A-4 and NFPA 302 recommends that fire protection systems be inspected and reweighed at one year intervals and tagged accordingly. Recommend compliance. NOTE: USCG standards (46 CFR 25) for vessels 26 to 40 feet require two BI extinguishers or one BI and one fixed system. ABYC A-4.6.3 and NFPA 302 Chapter 12 recommends at least three fire extinguishers: One outside the engine and or generator compartment, one at the steering position, and one near the galley or cockpit area. Recommend compliance with ABYC and NFPA for this size vessel. Fire extinguishers should be permanently mounted and readily available using the mounting system for the brand chosen. |

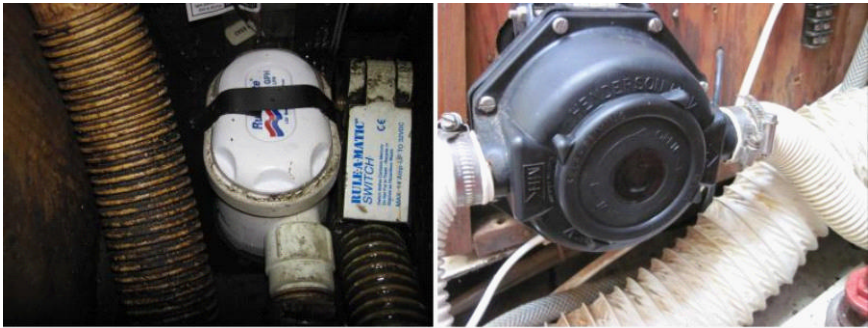
Electric and manual bilge pumps on board

One bilge pump was sighted on board this vesse just forward of the vee drive system in the lowest part of the bilge. The bilge pump was a 12 volt "Rule" brand 1000 GPH bilge pump with an external float switch. The bilge pumps were wired into a fused protected circuits as recommended by ABYC. The bilge pump powered up when tested. The float switch was functional when tested.

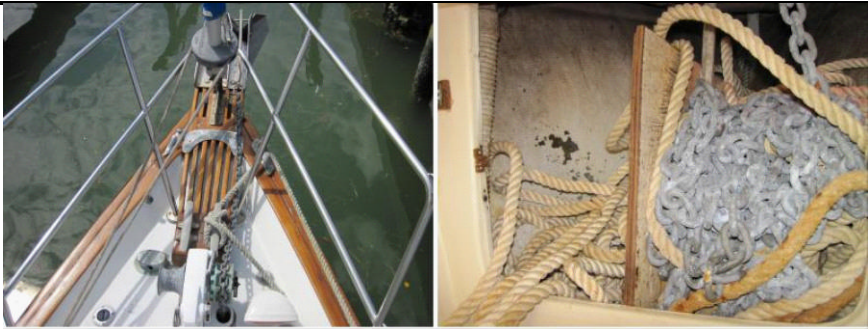
Ground tackle system

The primary anchor was a galvanized steel plow type anchor. The anchor was properly rated for this size vessel. The anchor was attached to approximate 25 five feet of 3/8 inch diameter galvanized steel chain which attached to approximately 150 feet of 9/16 inch diameter three strand right lay nylon line. The entire ground tackle was in good condition when inspected.

| Findings: | Recommendations: |
|---|---|
| Stainless steel wire was not moused to the shackles on the ground tackle. | It is a good practice of seamanship that stainless steel wire be tied into the shackle and shackle pin to prevent the pin from backing out of the shackle while the anchor is deployed. |

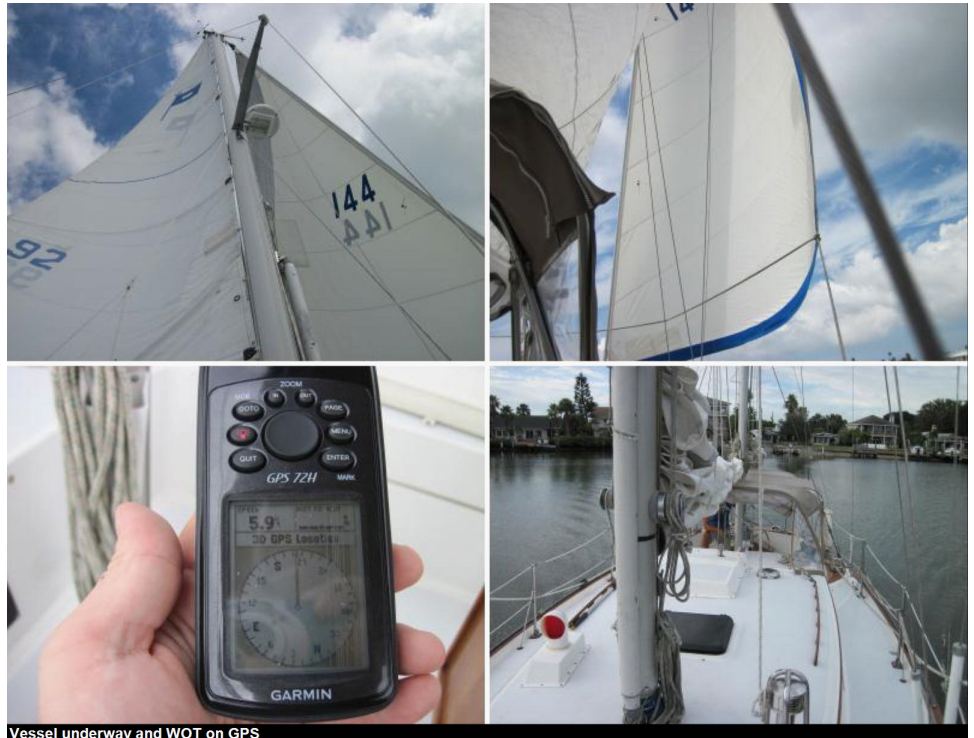
Vessel underway and WOT on GPS

The vessel's engine started up properly and the engine had adequate exhaust discharge. The exhaust smoke was normal with no unusual vapors noticed. The

The vessel's wide open throttle (WOT) was recorded at 5.9 knots sustained. No tachometer reading could be recorded due to the tachometer gauge not working (already noted in this report). The vessel was able to back down properly but the throttle cable broke on the third trial to back down. The turning radius of the vessel was approximately 35 feet when the rudder was turned hard over on the port and starboard sides. The vessel's turning radius was equal on both sides. After running the engines and generator, the following temperature readings were recorded (all readings were recorded in degrees fahrenheit with a calibrated thermal imaging camera): Engine block: 242 degrees, and exhaust manifold: 165 degrees. No significant variation in temperatures were sighted around the cylinder heads on the engine. All temperature readings were within normal limits however the engine block was running a little hotter than normal. No leaks were sighted in any of the exhaust or hull pass through locations during the sea trial. All engine mounts appeared to be secure during the sea trial. The vessel's sails and rigging were in good condition and were functional during the sailing phase of the sea trial. No shock loading of the rigging was sighted. The masts did not excessively bend or show signs of fatigue while under sail.
