REPORT OF MARINE SURVEY

Steel Hull Survey / Ultrasonic Testing of the Vessel

"New Smyrna Inlet"

1973 Diamond Manufacturing 42' Tug and Towing Vessel

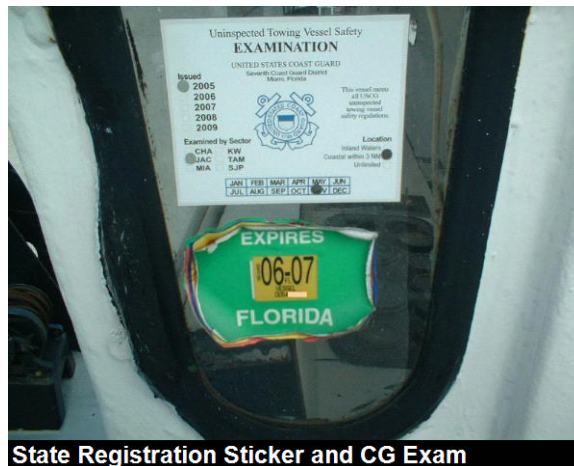
State Registration Sticker and CG Exam

Florida 19017469 (Registration sticker sighted on the vessel expired in June, 2007).
